Subj: Report of independent investigation of major aircraft accident
involving R7V-1 Bu. No. 128441 on 31 October 1954

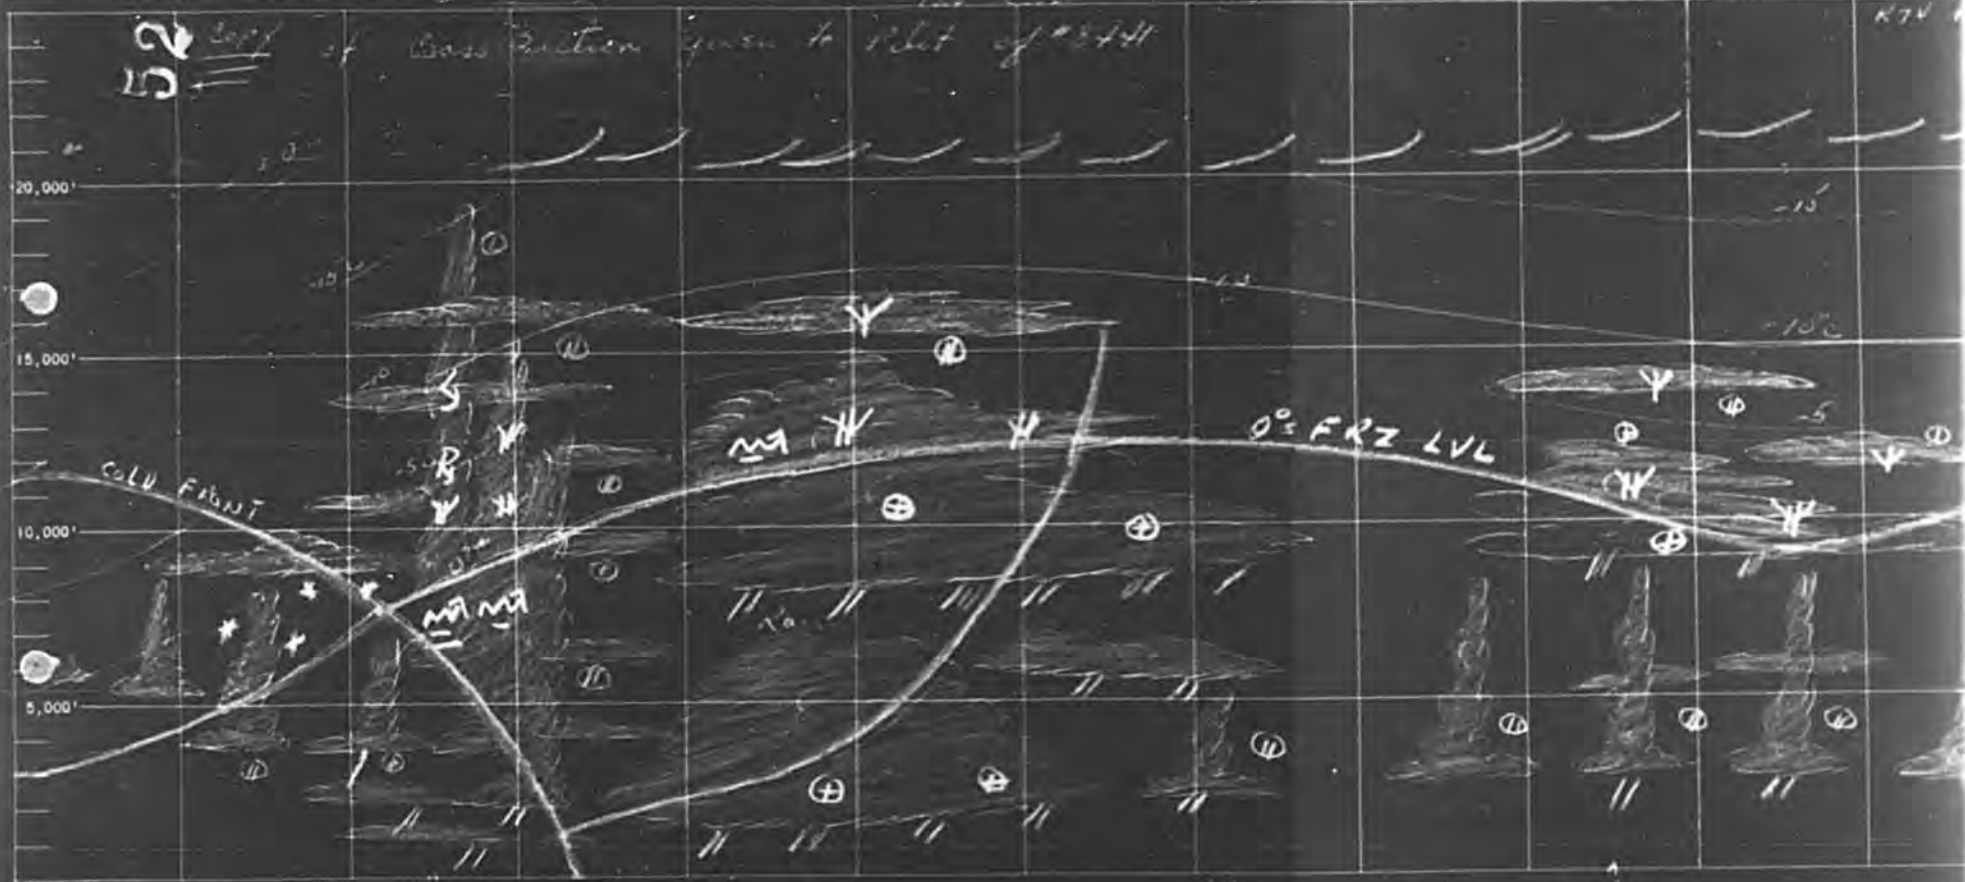
VERTICAL CROSS SECTION

FROM N.H.K. TO L.H.D. TRACK 200 + 400 E.T.D. 31/013
4/6 3100 A GP
